## Product Correction Notice

Date: 12 May 2011

# NTDW59BAE6 Issue - Keycode Not Matching

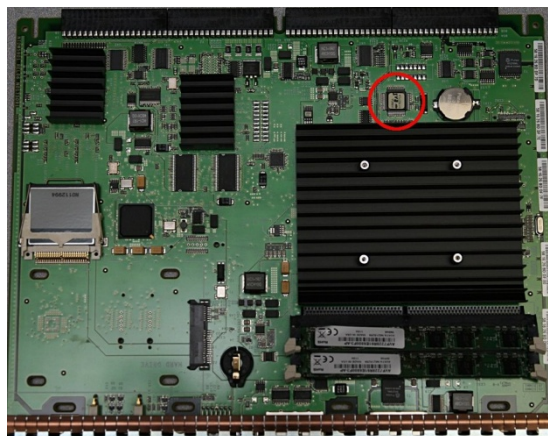
The root cause of the issue, is that during manufacture, the card was programmed with incorrect firmware. When the wrong firmware is loaded, the switch will not come up and will fail at the keycode validation step and print out a “keycode does not match the HW type” message.

1. The card can be screened in the box by checking the label on IC at location U26 (80 pin device beside the battery). The label should read: W58DA, R1.5, FEA3. The release will differ from R1.5 if the card has the wrong firmware

For NTDW59BAE6 cards with the incorrect firmware, the firmware can be upgraded on site by substituting the CPMG.BIN file. This file can be FTP'd to the compact flash using TTY0 to the MGC serial port only. The USB port does not connect to the MGC part of the board. Command instructions:

1. Enter: ctrl-I  
Control I detected. To change configuration enter mgcsetup  
> Init ISEC succeeded
2. ftp the CPMG.bin file to the CF on MG side (file attached)
3. issue below command under MG terminal, after the second command MG section should reboot.  
-> msp430FirmwareDownload "CPMG.bin"  
value = 0 = 0x0  
-> msp430UpgradeSwap  
value = 0 = 0x0
4. When MG section come up recheck the msp430 Version should be 6.  
-> msp430VersionGet  
value = 6 = 0x6
