IP Office Technical Bulletin

Bulletin No: 178
Release Date: 13 March 2015
Region: Global

General Availability (GA) - IP Office Release 9.1 Service Pack 1

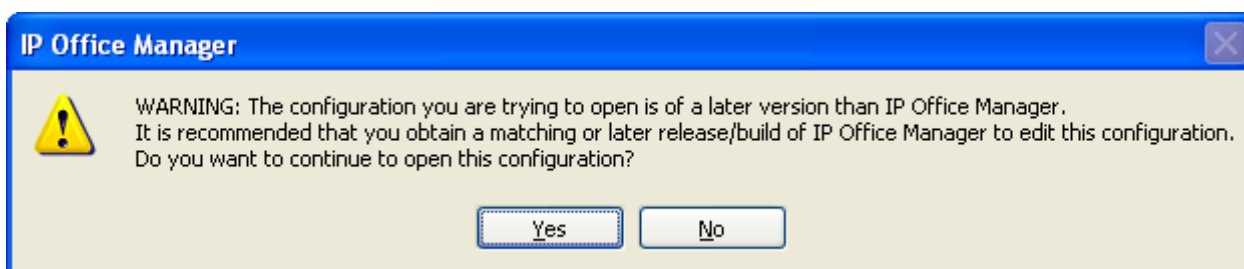
Earlier releases of IP Office 9.1 Manager are not compatible with systems running this release. Before upgrading an IP Office system to the 9.1.1.0.10 release, the Administration suite must also be upgraded. The following message will be displayed if attempting to access a system running the 9.1.1.0.10 release with an earlier version of Manager:

The IP Office Administration installer will detect previous installed versions and upgrade automatically. If a version earlier than 9.0 is installed, this must first be uninstalled before installing 9.1.1.0.10. It is not necessary to restart the PC after upgrading unless instructed to do so.
