PSN # PSN004539u

Original publication date: 21-Jul-15. This is Issue #10, published date: 15-Nov-16. Severity/risk level **High** Urgency **Immediately**

SAL Gateway does not support SHA-2 certificates; causes complete remote access failure. (Upgrade steps for System Platform 6.2 and later were greatly simplified in issue 8.) (Issue 9 was updated with information on the latest service packs.)

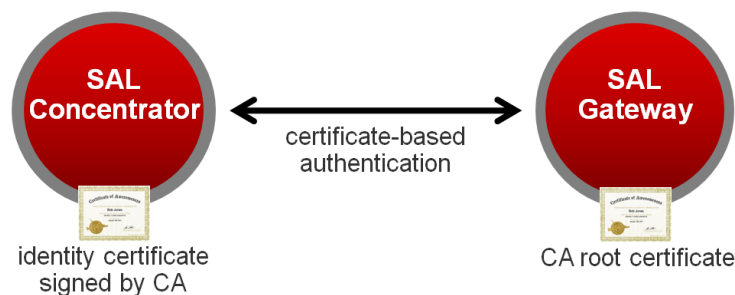
A SAL Gateway on a customer premise communicates with a SAL Concentrator in the Avaya datacenter (or in some cases in the business partner datacenter). The authenticity of the concentrator is verified using digital certificates. The Avaya SAL Concentrator presents an identity certificate which is signed by a certificate authority (CA), and the SAL Gateway authenticates that certificate by using a CA root certificate.

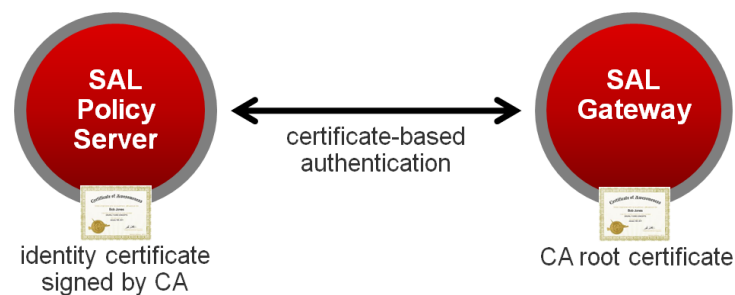
A similar authentication process can occur between the SAL Policy Server and the SAL Gateway, with a different set of certificates that may be provided by the customer. This authentication does not occur if the customer does not load these certificates.
