IP Office Technical Bulletin

Bulletin No: 212
Release Date: 15th December 2017
Region: Global

General Availability (GA) - IP Office Release 10.1 Service Pack 1

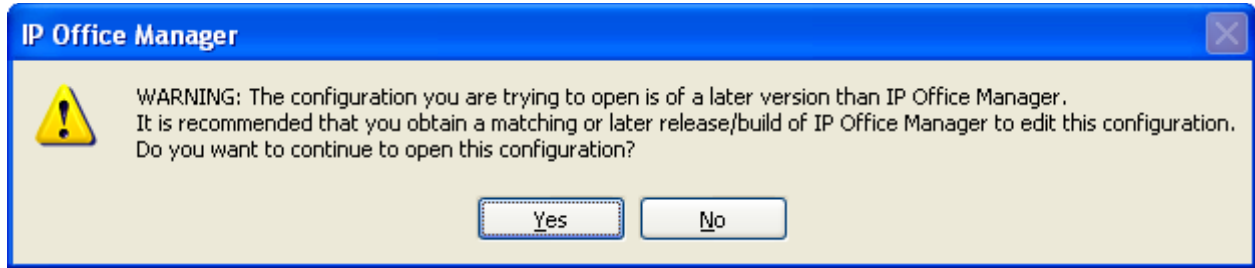
The previous GA release of IP Office 10.1 Manager is not compatible with systems running this release. Before upgrading an IP Office system to the 10.1.0.1.0.3 release, the Administration suite must also be upgraded. The following message will be displayed if attempting to access a system running the 10.1.0.1.0.3 release with an earlier version of Manager:

The IP Office Administration installer will detect previous installed versions and upgrade automatically. If a version earlier than 9.0 is installed, this must first be uninstalled before installing 10.1.0.1.0.3. It is not necessary to restart the PC after upgrading unless instructed to do so.
