IP Office Technical Bulletin

Bulletin No: 213
Release Date: 13th April 2018
Region: Global

General Availability (GA) - IP Office Release 10.1 Service Pack 2

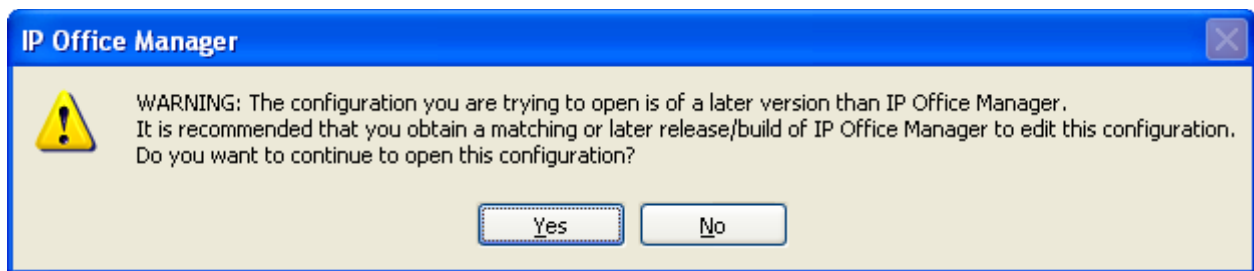
The previous GA release of IP Office 10.1 Manager is not compatible with systems running this release. Before upgrading an IP Office system to the 10.1.0.2.0.2 release, the Administration suite must also be upgraded. The following message will be displayed if attempting to access a system running the 10.1.0.2.0.2 release with an earlier version of Manager:

The IP Office Administration installer will detect previous installed versions and upgrade automatically. If a version earlier than 9.0 is installed, this must first be uninstalled before installing 10.1.0.2.0.2. It is not necessary to restart the PC after upgrading unless instructed to do so.
