## IP Office Technical Bulletin

**Bulletin No:** 215  
**Release Date:** 23rd July 2018  
**Region:** Global

### **General Availability (GA) - IP Office Release 10.1 Service Pack 3**

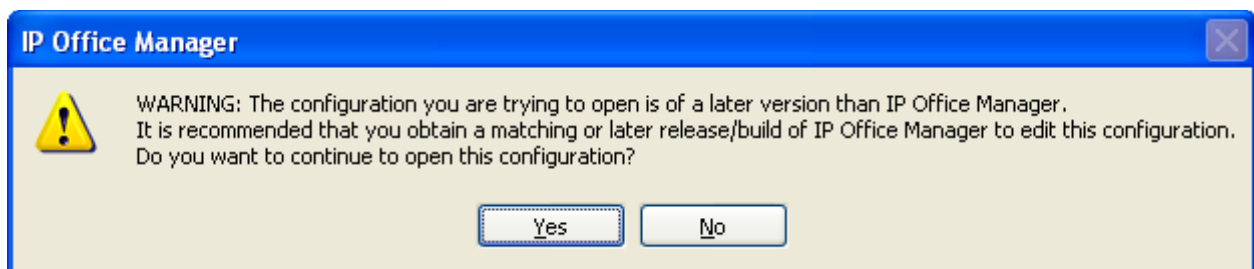
The previous GA release of IP Office 10.1 Manager is not compatible with systems running this release. Before upgrading an IP Office system to the 10.1.0.3.0.2 release, the Administration suite must also be upgraded. The following message will be displayed if attempting to access a system running the 10.1.0.3.0.2 release with an earlier version of Manager:

The IP Office Administration installer will detect previous installed versions and upgrade automatically. If a version earlier than 9.0 is installed, this must first be uninstalled before installing 10.1.0.3.0.2. It is not necessary to restart the PC after upgrading unless instructed to do so.
