Ethernet Routing Switch 5500 Series

Release Notes — Software Release 5.1

Document status: Standard
Document version: 03.02
Document date: 22 October 2007

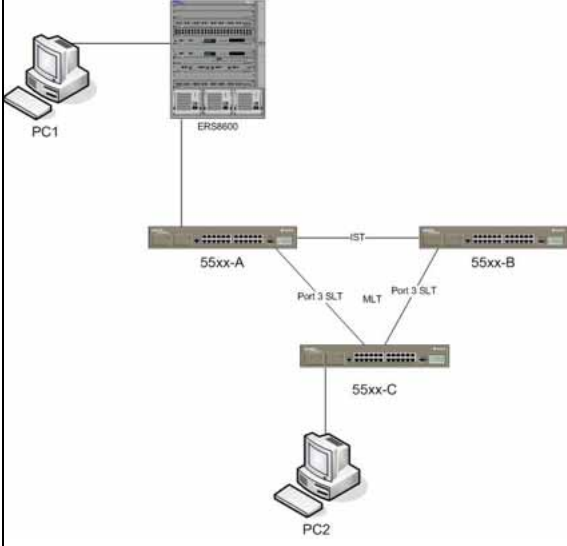
Q01737679	<p>In an SMLT environment, the traffic received on an IST port is categorized into two groups: IST switched and routed packets. To prevent a loop condition, the switch must block IST switched packets (broadcast, multicast, and unknown unicast traffic) from egressing to any SMLT or SLT ports.</p> <p>However, SMLT switch must be able to forward IST routed packets to any specific SMLT or SLT port as requested by the routing engine. A hardware limitation, ERS55xx blocks both IST switched and routed packets from exiting SMLT or SLT ports. As a result, some of the L3 traffic will be lost. When you configure ERS55xx with both SMLT and L3 dynamic routing protocols (OSPF, RIP), you must avoid the topology in which the L3 traffic received on an SMLT switch is routed to the other SMLT peer because it is a better route.</p>

Reference number	Description
	<p>In the preceding figure, 86xx has two routes to reach PC2. The first route is to 55xx-a and then 55xx-c. The second route is to 55xx-b and then 55xx-c. If 8600 uses second route, the traffic from PC1 will never reach PC2.</p> <p>To force the 86xx to take the first route, you must configure VRRP with Backup/Master enabled on both SMLT switches.</p> <p>Then static route with the best cost to the VRRP must be added to 86xx to make sure 86xx always chooses 55xx-a as the next hop to reach PC2.</p>
Q01738603	If you use the non-EAP phone feature in Layer 3 mode with DHCP Relay, it may disrupt Layer 3 connectivity. Nortel recommends that you deploy this feature only in Layer 2 mode.
Q01738540	A hardware limitation means that once you program the filter, it blocks all IPs that are not allowed. The switch does not show which IP was dropped.
Q01738600	When you enable NSNA, DHCP clients connected to non-NSNA ports will not receive DHCP packets sent from NSNA uplink server ports. Nortel recommends that you connect the DHCP server through a non-NSNA uplink port.
