CallPilot 5.1 - Distributor Technical Reference

This Distributor Technical Reference (DTR) bulletin provides information that supplements the formal documentation for the purpose of installing, upgrading, and supporting Avaya CallPilot® Release 5.1 (build 05.01) systems. It provides updated procedures, limitations, known problems, workarounds, and documentation addendum. This is an important information resource for Business Partner field operations and support personnel involved with CallPilot 5.1.

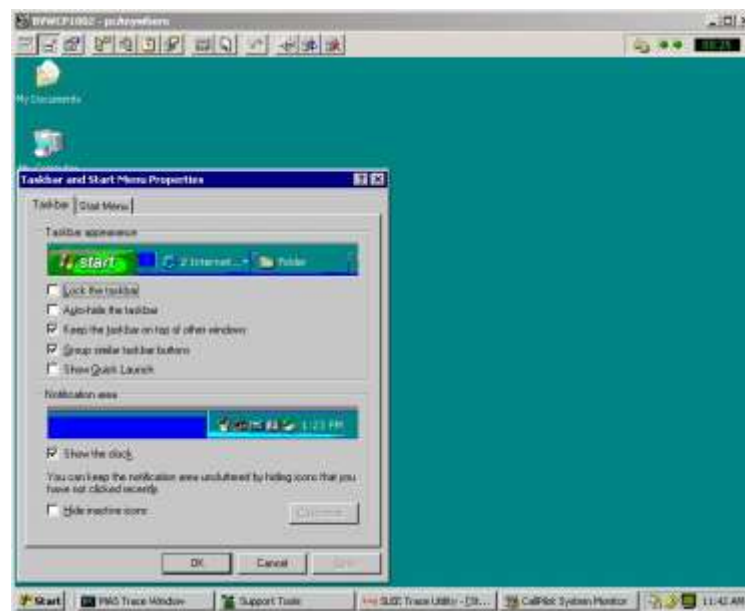
Whenever the MAS window is minimized, the Taskbar Menu pops up as indicated (see below). Additionally, sometimes closing the Taskbar Menu results in the MAS window appearing in the center of the screen again. This behavior is primarily observed when using pcAnywhere. Refer to CR # Q00947757.

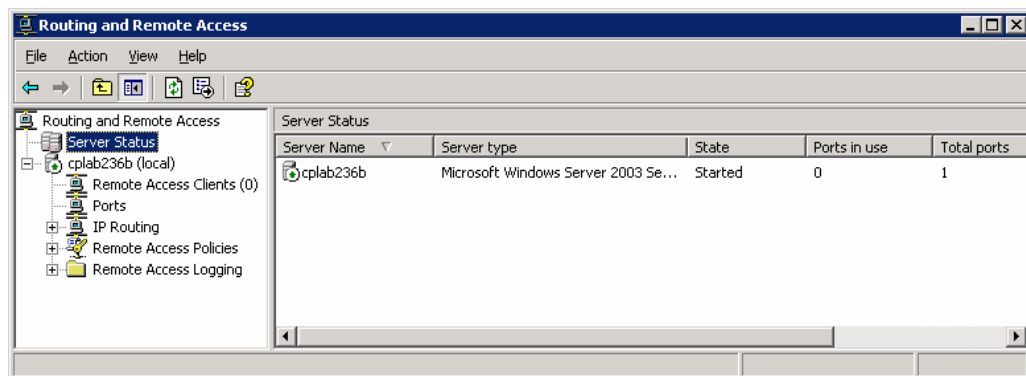
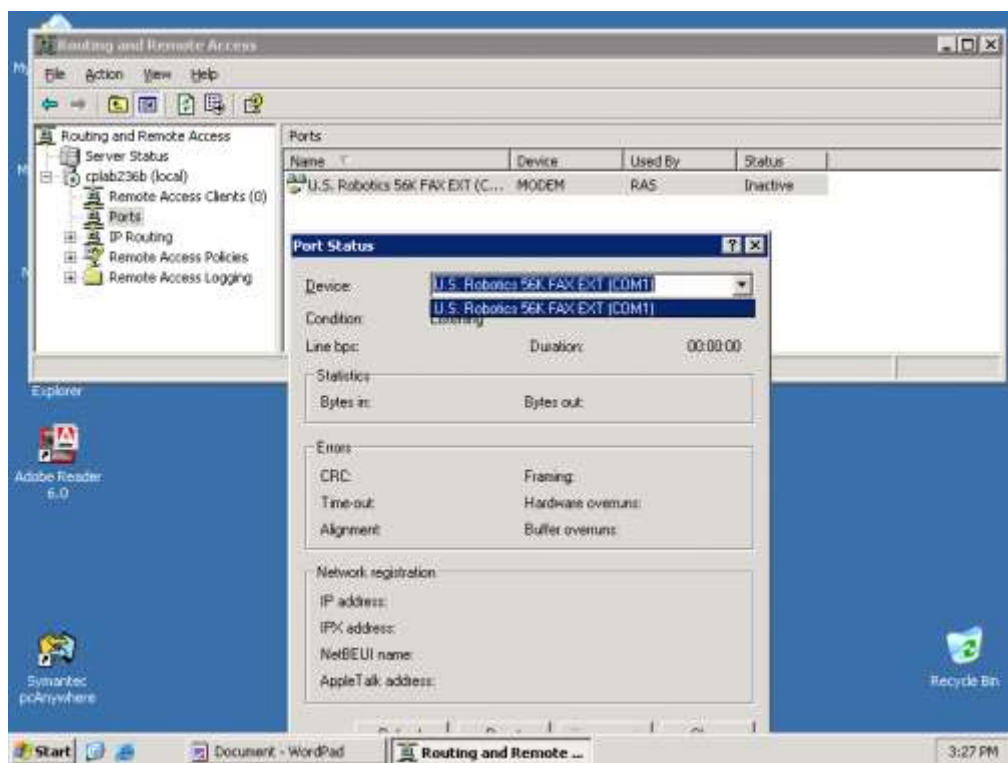
To verify if two devices are connected to COM1, look into the Routing and Remote Access application (Start > Programs > Administrative Tools > Routing and Remote Access). Under Server Status there should only be one (1) total port. In the case of this failure, there may be two (2) or more.

Under Ports, select the modem and then Status. There should be only one device listed in the drop down list box (U.S. Robotics 56K FAX EXT (COM1), but in this case there was also the Standard 33600 modem.

The only method of removing the incorrect modem (e.g. Standard 33600 modem) from RRAS is to remove it from the system.

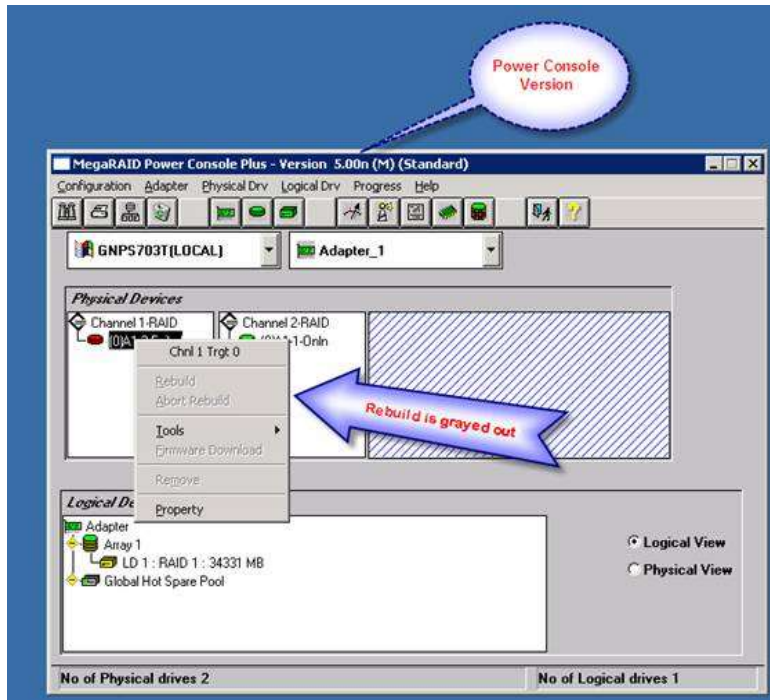
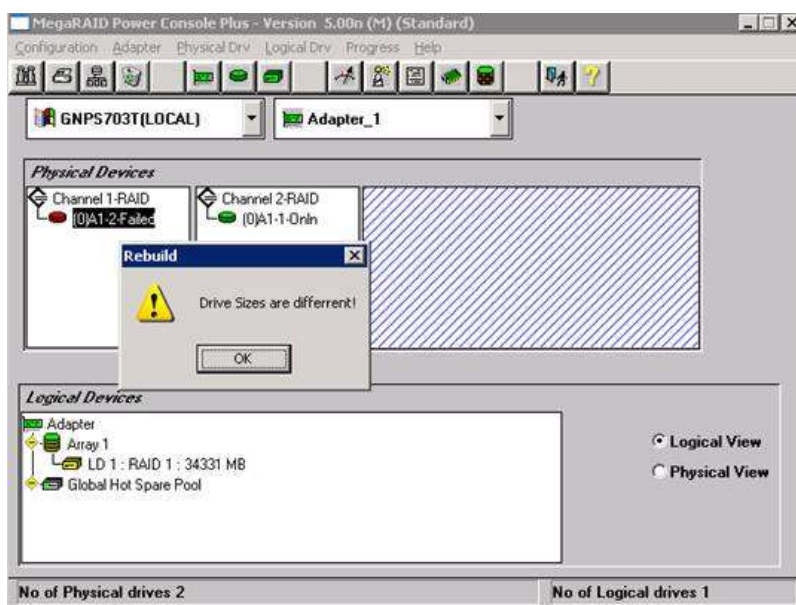
This problem only happens on systems using the LSI1600 RAID card and Mega RAID Power Console Plus GUI version 5.00n (CallPilot 1002rp and 703t servers using the LSI1600 RAID card).

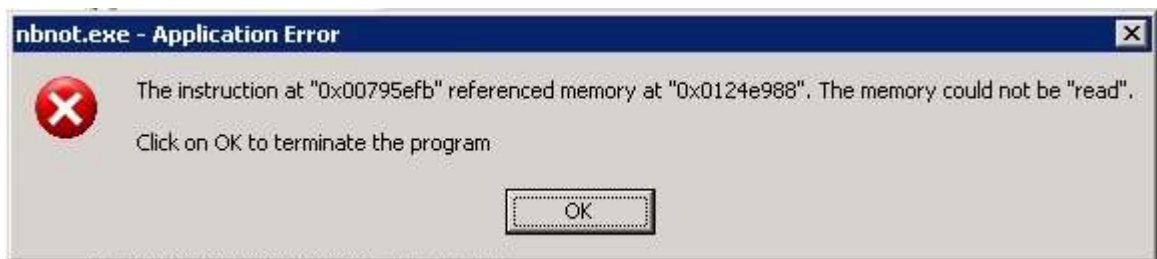
Infrequently, after uninstalling CallPilot Manager, during the re-install, the following Application Error window may appear. Refer to wi01186868.

Workaround: There is no impact of this pop-up window. Click OK to resume re-installation of CallPilot Manager and other PEP updates.

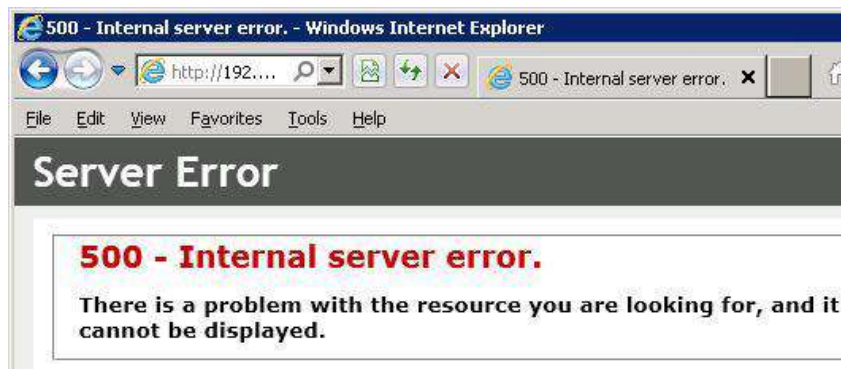
When CallPilot Manager/Reporter is installed on freshly imaged Windows Server 2008, CallPilot Manager cannot be launched with error 500 - Internal server error. Refer to wi01121523. See below for error message and solution.

Solution: To avoid the issue, ASP.Net Role Service must be installed.

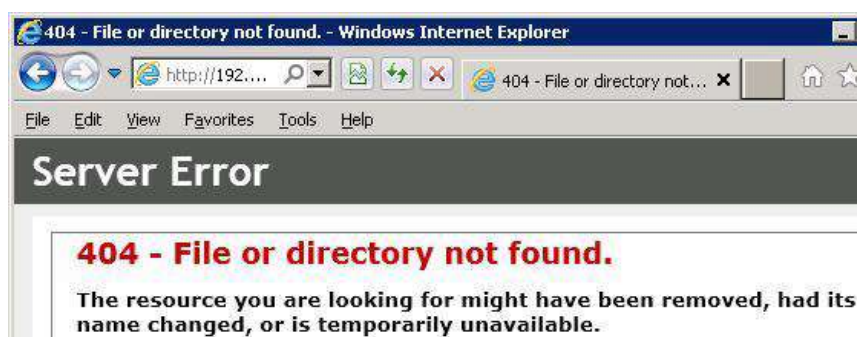
When CallPilot Manager/Reporter is installed on freshly imaged Windows Server 2008, CallPilot Manager cannot be launched with error 404 - File or directory not found. Refer to wi01121523. See below for error message and solution.

Solution: To avoid the issue, ASP Role Service must be installed.

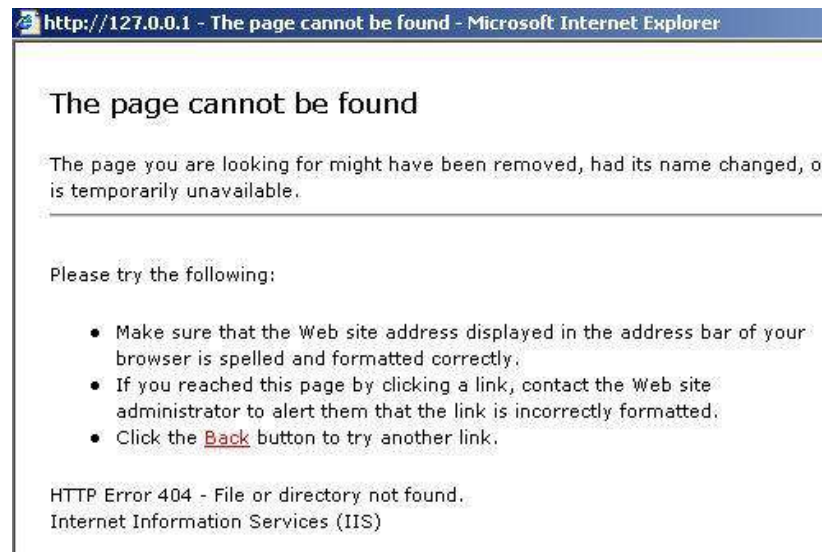
When CallPilot Manager/Reporter is installed on freshly imaged Windows Server 2003, Reports cannot be launched with error 404 - File or directory not found. Refer to wi01121523. See below for error message and solution.

Solution: To avoid the issue, .Net Framework v2.0 or higher must be installed.

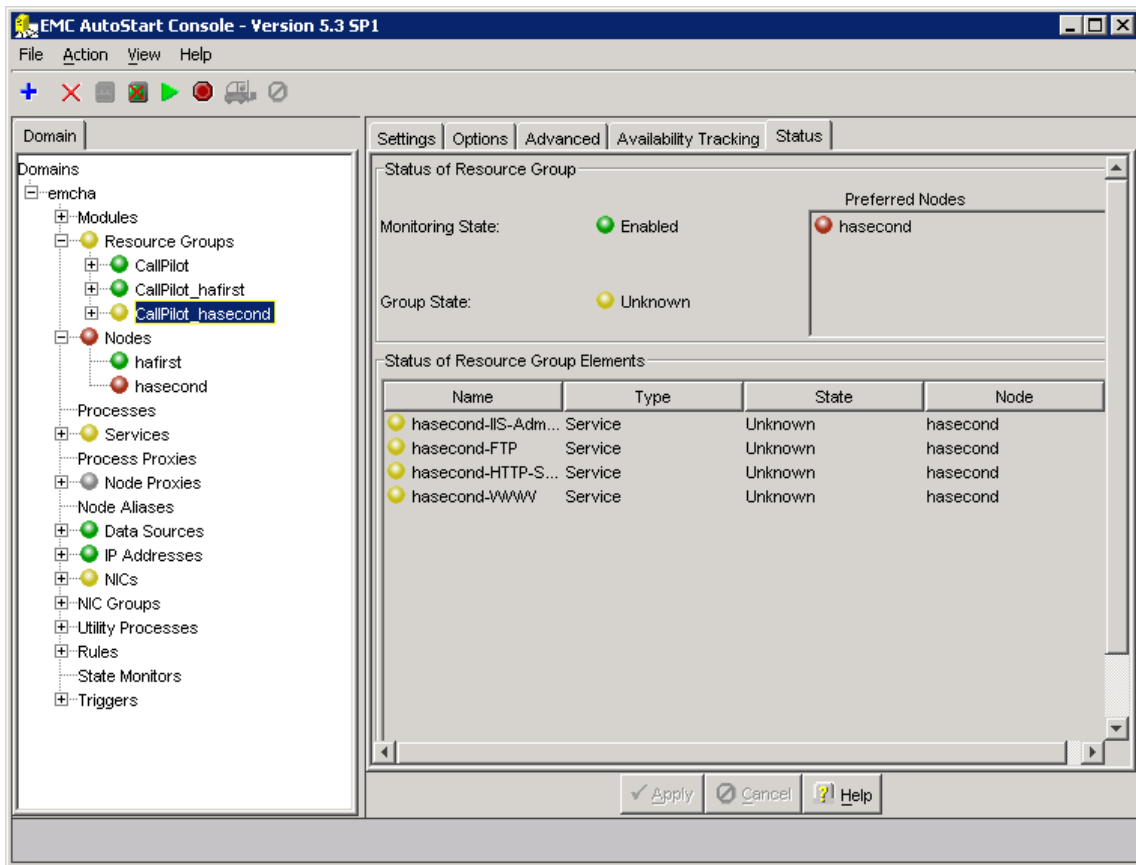
1. Mandatory services are down on the standby server. Example:
