Ethernet Routing Switch 8300

Software Release 4.2.3.11

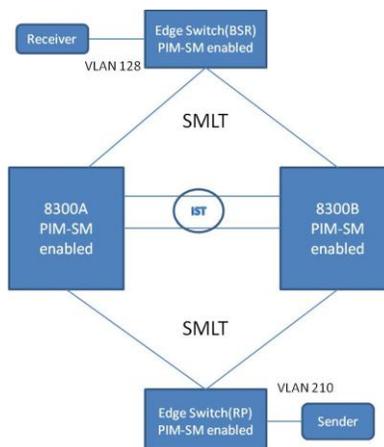
- For the scenario where the IST/SMLT switches are configured as Layer-3 transit network for multicast stream and the multicast source and receiver are located on two different SMLT edge switches of the same IST peer cluster, a PIM Multicast routing loop may occur over IST links. This scenario can now be avoided by enabling a new CLI/ACLI parameter called pim-ist-protect. By default, it is disabled and will need to be turned on to handle the above scenario [WI01088695]

Example configuration of sender and receiver on different edge switches of the same IST cluster.

PPCLI(rwa/rwa):
 config pim-ist-protect <enable | disable | info>

ACLI(rwa/rwa):
 config t;
 pim-ist-protect;
 <no | default> pim-ist-protect;
 show pim-ist-protect;
