# Ethernet Routing Switch 8300

Software Release 4.2.3.12

## **1. Release Summary**

Purpose : Software maintenance release to address specific customer found issues.

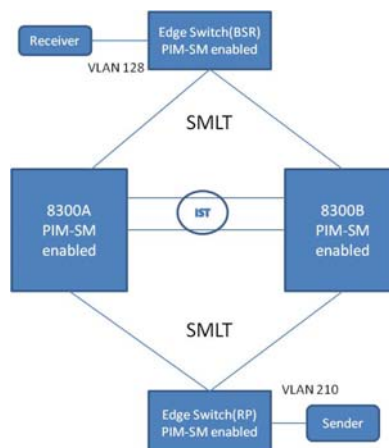
- For the scenario where the IST/SMLT switches are configured as Layer-3 transit network for multicast stream and the multicast source and receiver are located on two different SMLT edge switches of the same IST peer cluster, a PIM Multicast routing loop may occur over IST links. This scenario can now be avoided by enabling a new CLI/ACLI parameter called pim-ist-protect. By default, it is disabled and will need to be turned on to handle the above scenario [WI01088695]

*Example configuration of sender and receiver on different edge switches of the same IST cluster.*

PPCLI(rwa/rwa):  
 config pim-ist-protect <enable | disable | info>

ACLI(rwa/rwa):  
 config t;  
 pim-ist-protect;  
 <no | default> pim-ist-protect;  
 show pim-ist-protect;
