IP Office Technical Bulletin

Bulletin No: 219
Release Date: 1st April 2019
Region: Global

General Availability (GA) - IP Office Release 10.1 Service Pack 5

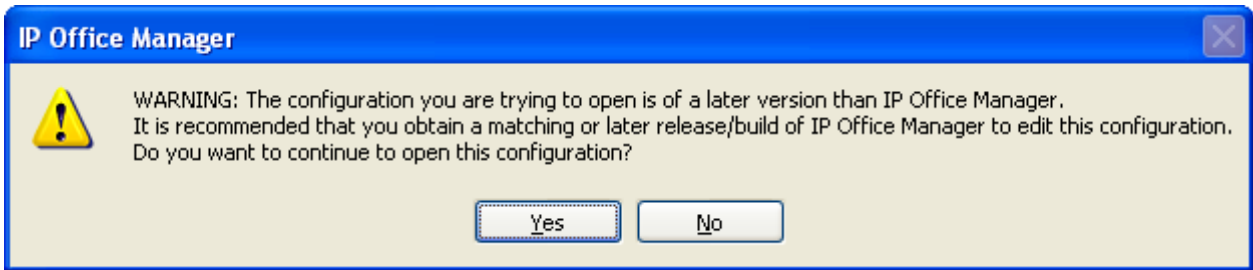
The previous GA release of IP Office 10.1 Manager is not compatible with systems running this release. Before upgrading an IP Office system to the 10.1.0.5.0.4 release, the Administration suite must also be upgraded. The following message will be displayed if attempting to access a system running the 10.1.0.5.0.4 release with an earlier version of Manager:

The IP Office Administration installer will detect previous installed versions and upgrade automatically. If a version earlier than 9.0 is installed, this must first be uninstalled before installing 10.1.0.5.0.4. It is not necessary to restart the PC after upgrading unless instructed to do so.
