CallPilot 5.1 - Distributor Technical Reference

This Distributor Technical Reference (DTR) bulletin provides information that supplements the formal documentation for the purpose of installing, upgrading, and supporting Avaya CallPilot® Release 5.1 (build 05.01) systems. It provides updated procedures, limitations, known problems, workarounds, and documentation addendum. This is an important information resource for Business Partner field operations and support personnel involved with CallPilot 5.1.

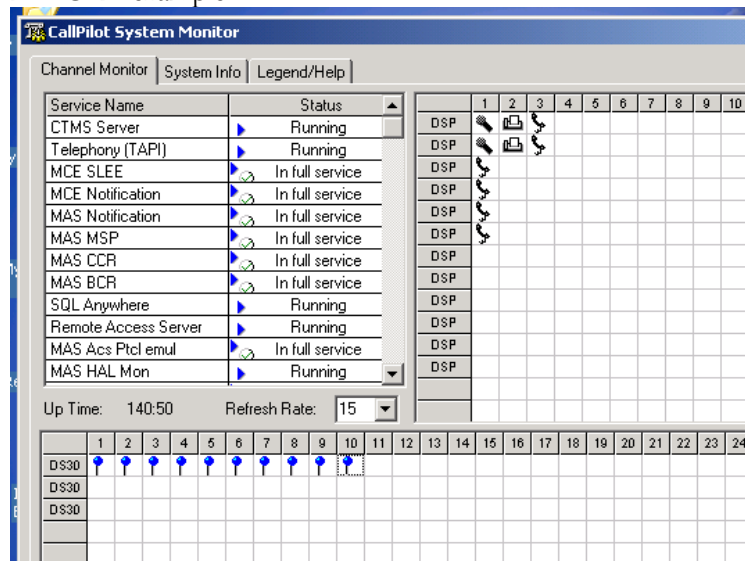
BEFORE example:

As a workaround to prevent the DSPs from getting into the RNA state, on 201i IPE only, Voice and Fax DSP Resources should be re-arranged to separate DSP. Therefore after the workaround is implemented no single DSP Card must contain both Voice and Fax Ports.

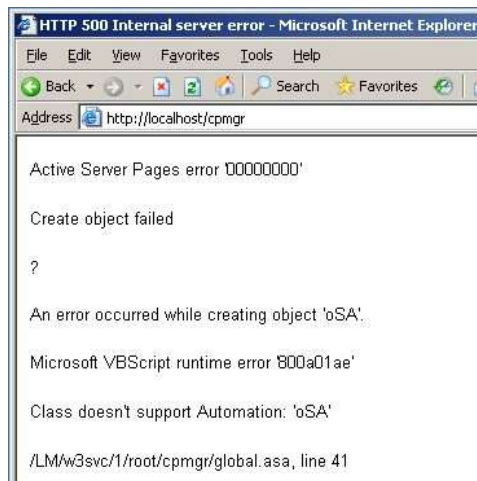
8.2.3 Cannot Launch CPMgr from standalone Windows Server 2003 Web Server configured as Domain Controller

When CallPilot Manager/Reporter is installed on Windows Server 2003 configured as a Domain Controller, CallPilot Manager cannot be launched. Refer to wi00934238. See below for error message and workaround.

Workaround: To avoid the issue, additional DCOM permissions must be set manually.
Please do not remove any user from the group list

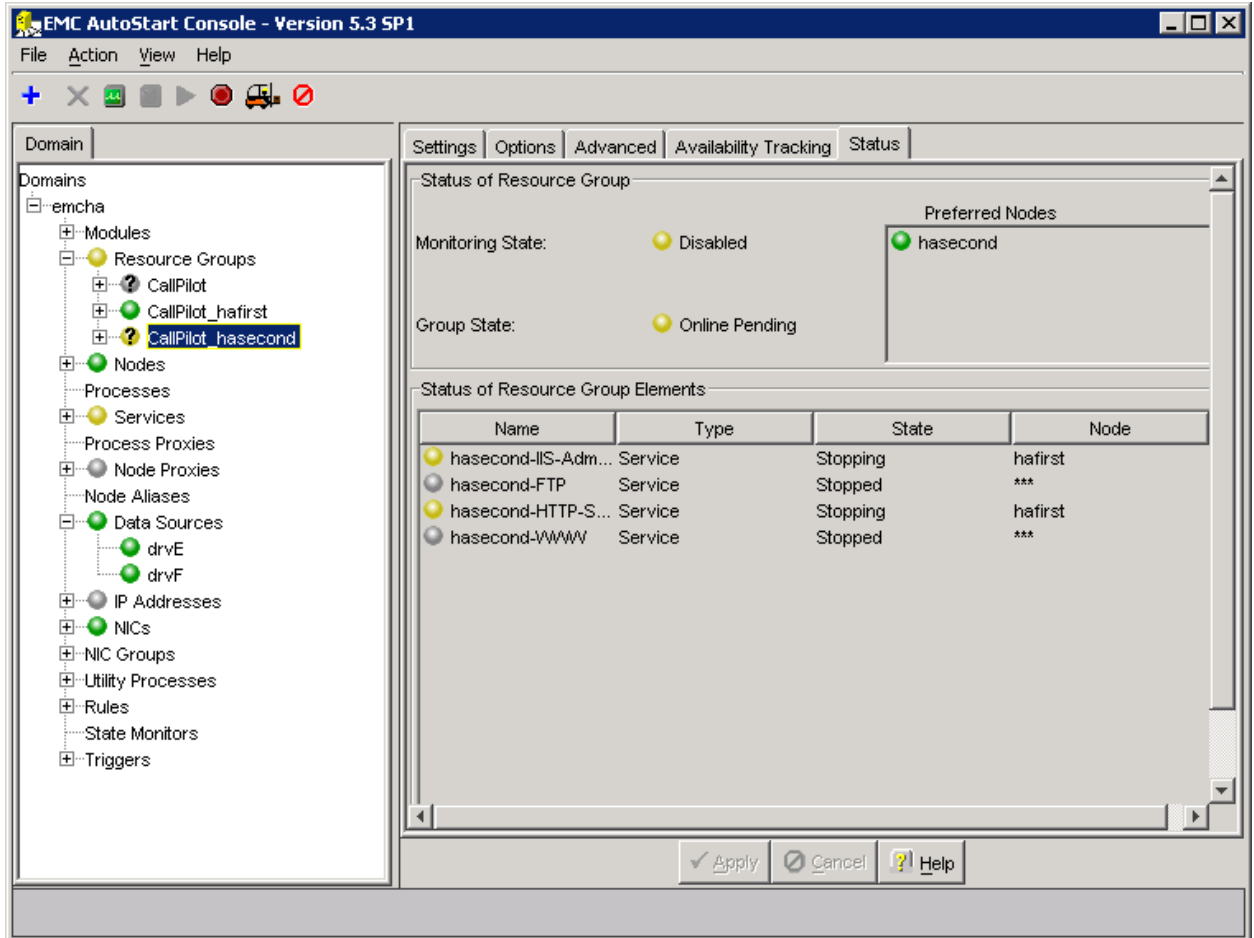
This chapter refers to the situation when a failure condition is detected on the active server. In this case one of the items in the AutoStart Console could be in a yellow or red state. The following picture illustrates that several services are stopped and that cause CallPilot failure.

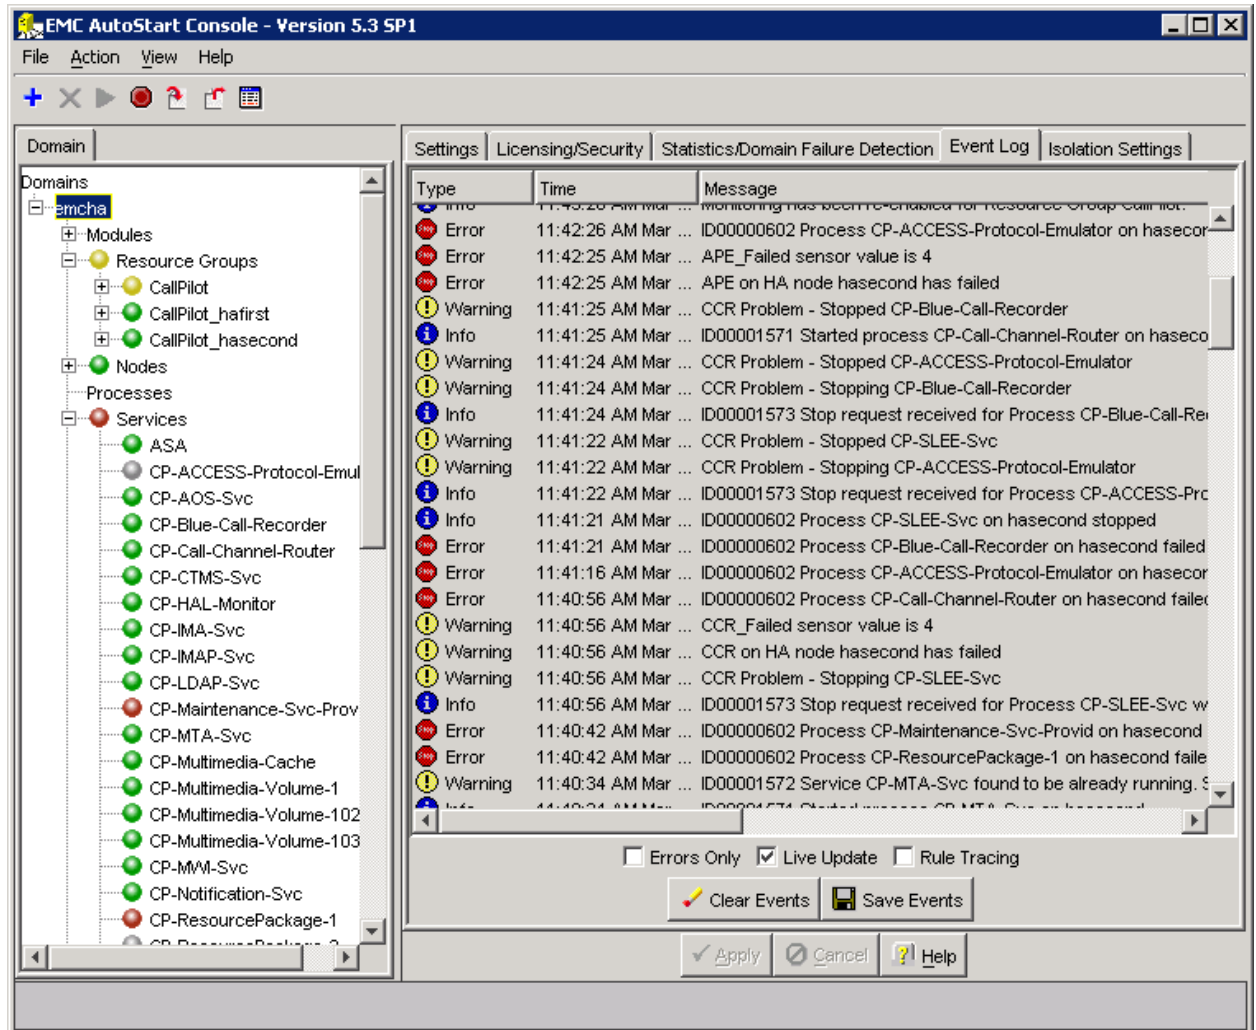
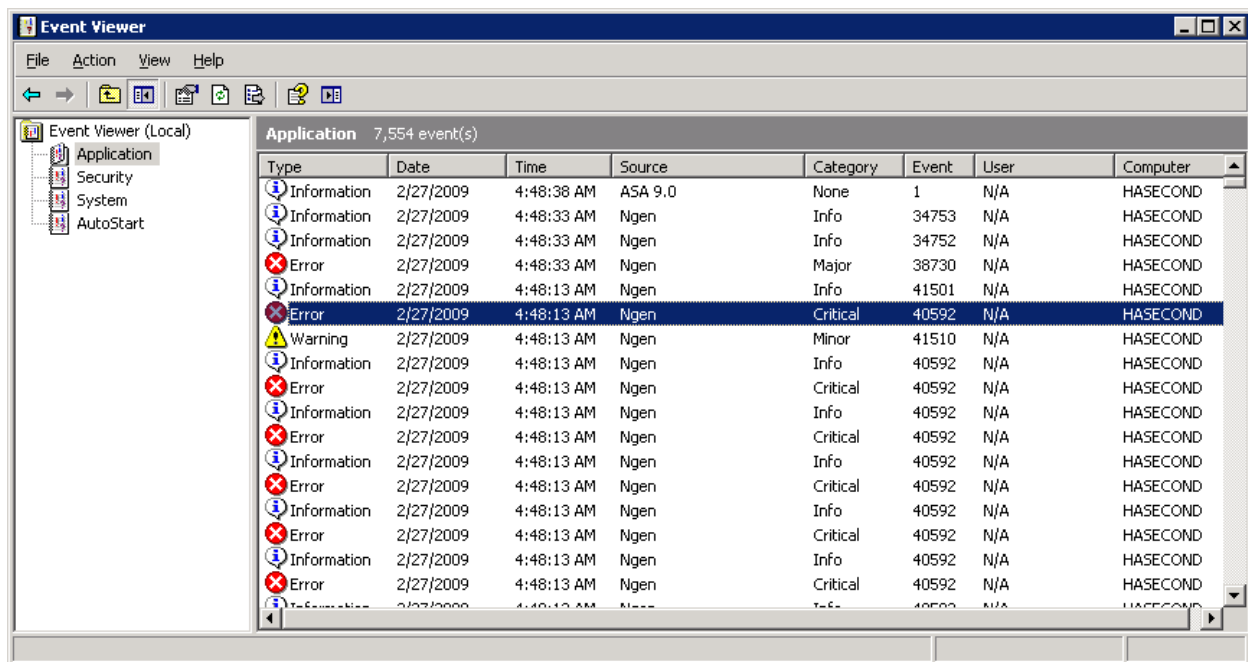
If the failover fails on the standby server then an error could be found in the AutoStart console and Windows even log as on the following screenshots for example:

The event 40592 shows that the CTMS Server failed to start, The CallPilot Blue Call Router service terminated and so on.

If the failover on the standby server is unsuccessful and monitoring is enabled, then the previously online server tries to start up.

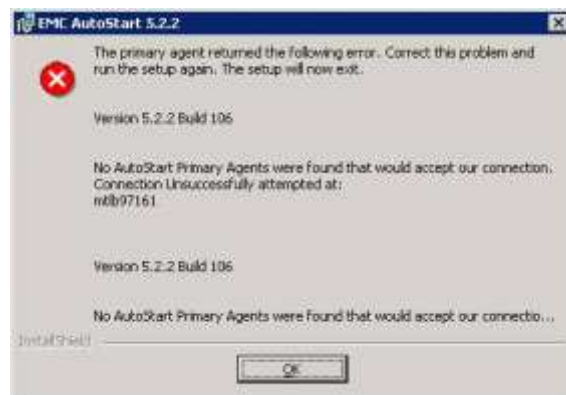
8. EMC AutoStart installation error

When configuring EMC AutoStart software on CP2, the following pop-up window may appear if the EMC AutoStart Transport Service is disabled:

Workaround: Ensure the EMC AutoStart Transport Service is enabled and re-attempt the installation and configuration.
