HP ProLiant Gen8 Troubleshooting Guide

Volume II: Error Messages

Part Number: 658801-002
June 2012
Edition: 2

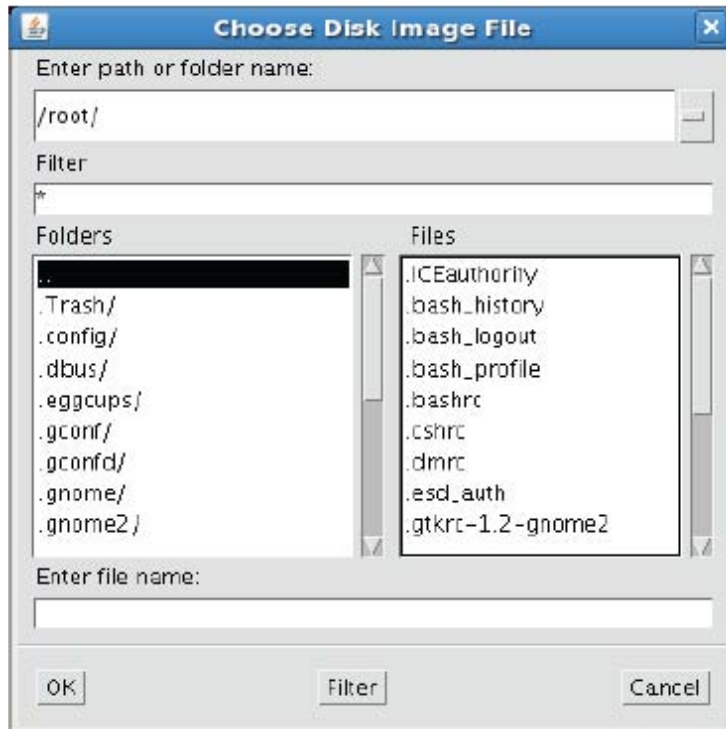
3. Log in to iLO using Firefox.
4. Insert a USB key or Floppy on the local client system. Ensure you can access them.
5. Open a Java IRC session.
6. Click **Virtual Drives>Floppy/USB-key**, and select Virtual Media. Verify the Linux box displays.

7. Type or select the path of the USB-key/floppy (**/dev/disk**) which is inserted to the client.
8. Click the **OK** button.
