Release Notes for Avaya Virtual Services Platform 7000 Series

Release 10.4
NN4702-400
Issue 10.07
February 2016

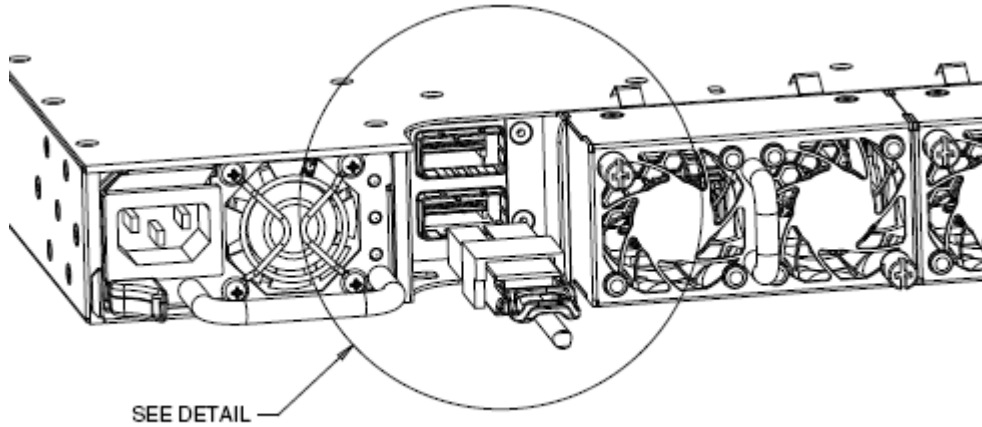
Figure 1: Installing Fabric Interconnect cables

Incorrect FI cable insertion can cause physical damage to the VSP 7000 Series switch. For more information, see the following figures.

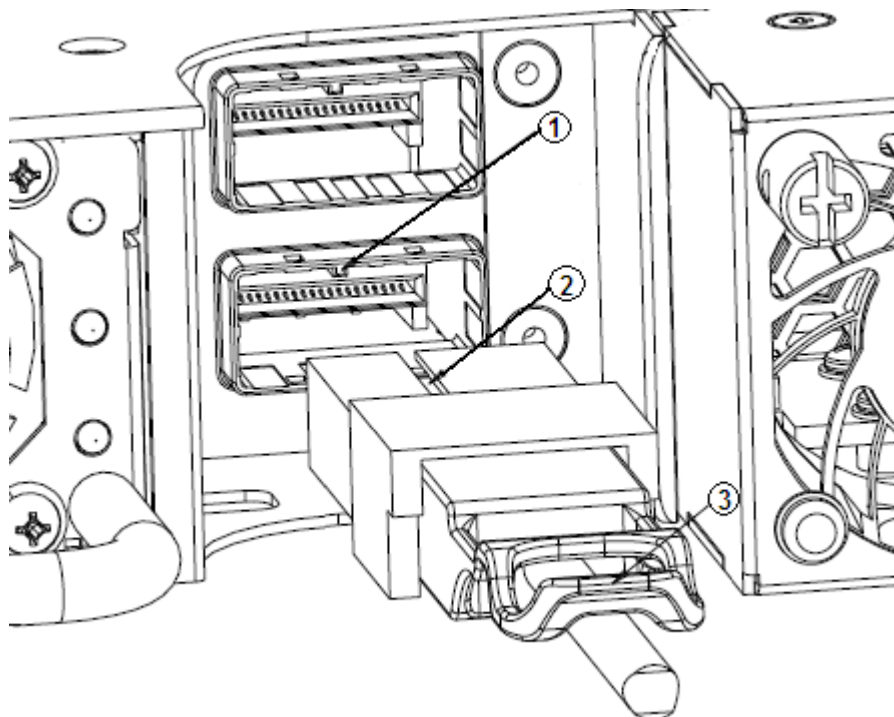
Figure 2: Installing Fabric Interconnect cables detail

Callout	Description
1	FI port alignment tab
2	FI cable alignment slot (Insert cable with slot facing UP and aligned with tab on the port)
3	FI cable connector pull tab (Ensure that the connector pull tab is facing UP)
